## SR 4099 Section EMR SR 4099 Emergency Slide Repair Abstract

A Scoping Field View was held via skype due to Coronavirus quarantine. This project is for the remediation of a slide area located on SR 4099 in East Vandergrift Borough, Westmoreland County. SR 4099 (East Vandergrift Lane) has a history of roadway subsidence. Voids develop under the roadway due to the geology of the area. The road is built on a hillside that is categorized as an ancient slide plane. The Department has previously made repairs to this area, but the deterioration has continued. Currently, a wall that was built to support the sidewalk is collapsing, exposing voids under the sidewalk.

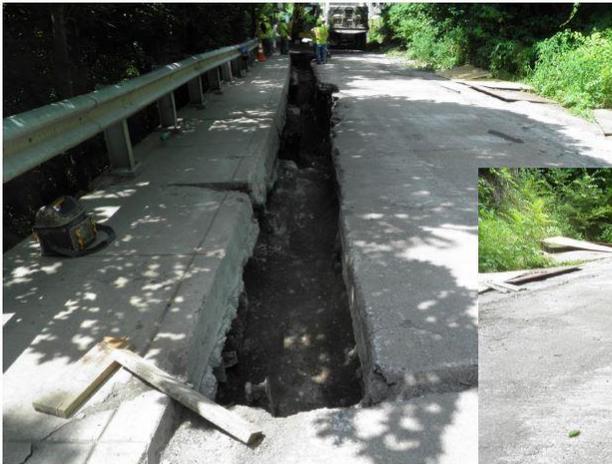
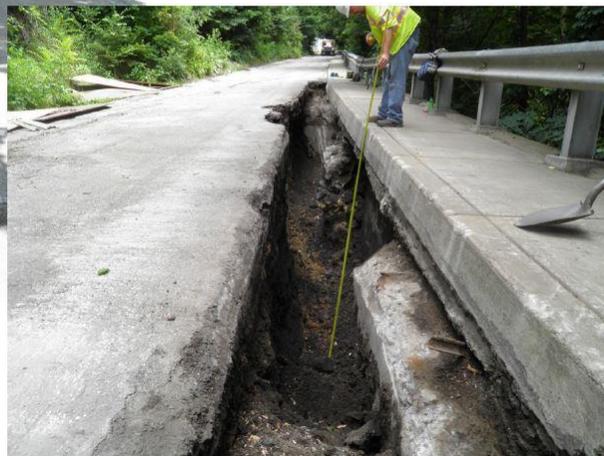
2. Repairs were completed to this area in June 2017 and consisted of: 2' wide, 8' deep, 40' long trench filled with Class C Concrete and bottom of excavation sloped towards the slope above the roadway (so as to force the concrete to 'fall back towards the uphill side of the trench').

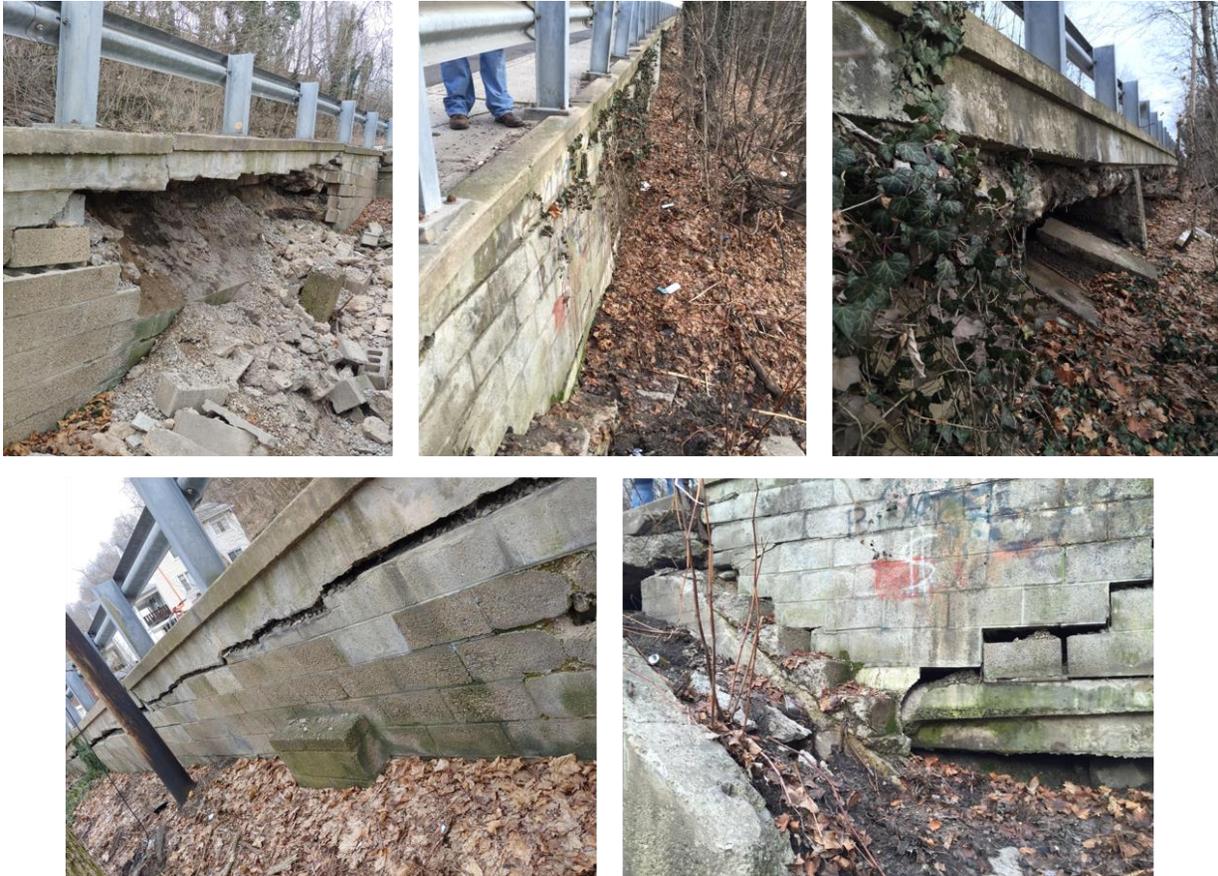
3. During a field view on Monday March 2, 2020, severe damage to the sidewalk structure was observed. This slide is slipping along the soil bedrock interface which varies

between 15 to 32 feet below the road surface. The most active area of the slide accounts for approximately 450 linear feet of roadway and sidewalk damage.

6. The proposed repair will install two lines of pipe dowels under the outside edge of the sidewalk to stabilize both the roadway and sidewalk. The sidewalk would be reconstructed, and structure mounted guiderail installed.

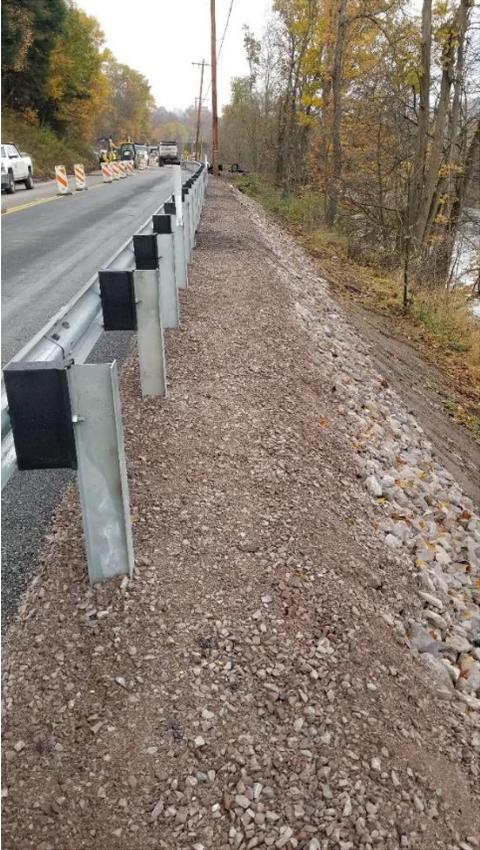
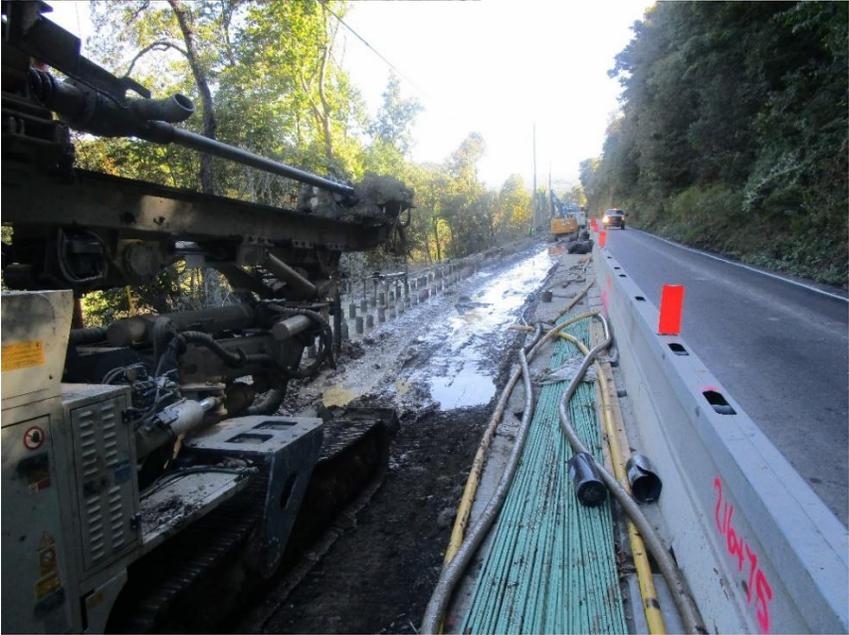
Following are pictures of a similar project where a staggered dowel system was used which is similar to what is being proposed. SR 4099's detail will provide a seamless transition from the existing sidewalk construction to the dowel system/sidewalk cap/structure-mounted guiderail.
